CULTURAL LANDSCAPE REPORT
FOR THE SANDY HOOK
COASTAL DEFENSE BATTERIES
GATEWAY NATIONAL RECREATION AREA

CULTURAL LANDSCAPE REPORT FOR THE SANDY HOOK COASTAL DEFENSE BATTERIES

GATEWAY NATIONAL RECREATION AREA

FORT HANCOCK, NEW JERSEY

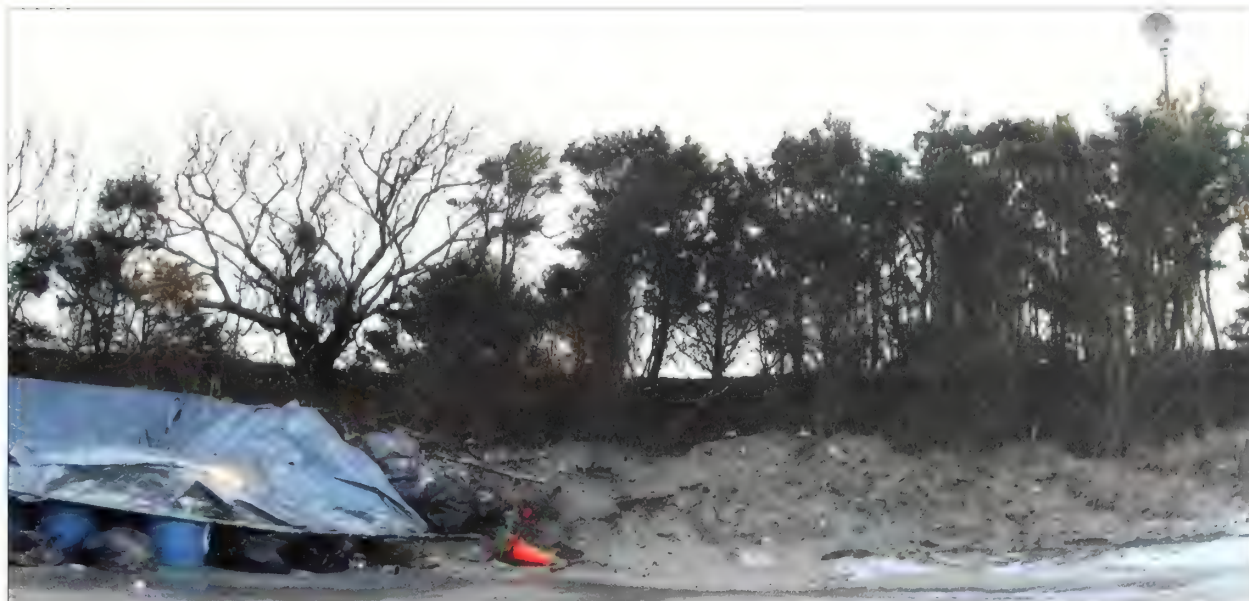
Figure 5.120. View looking southeast at Missile Maintenance Area historic earthwork, NIKE launch site. In addition to the recycling containers visible on the left, a debris pile from the state's beach cleaning program sits at the toe of the earthwork. The debris obscures the highly engineered shape of the earthwork and should be carefully removed to avoid damaging this feature (Olmsted Center, January 2009).

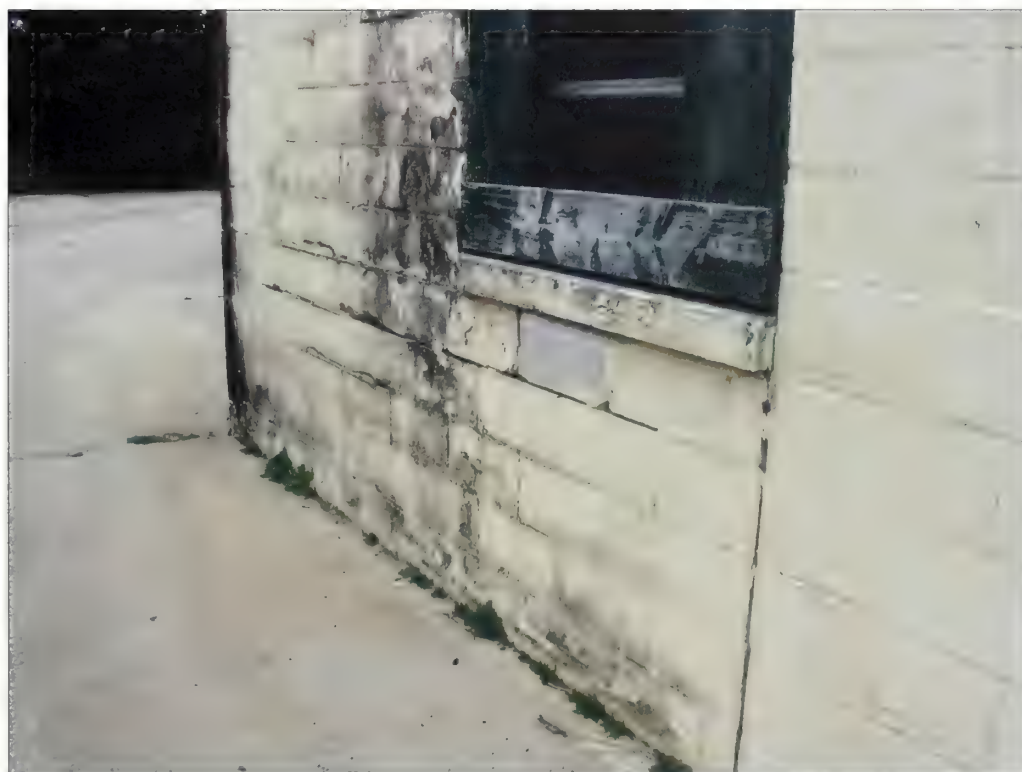
Figure 5.121. View looking northwest at Warhead Building (450), NIKE launch site. Routine maintenance procedures will help stabilize free-standing buildings in the launch site. The water damage seen in this image originates from a metal gutter mounted at the top of the wall that needs to be cleaned and reset so water is carried away from the building (Olmsted Center, April 2008).

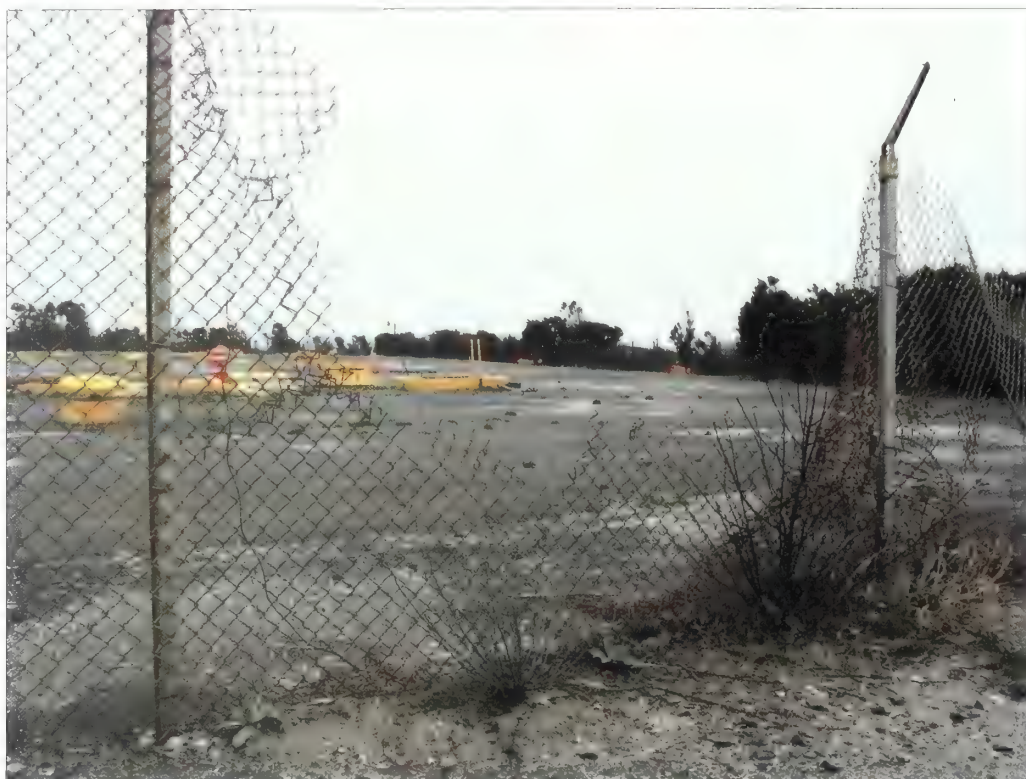
Figure 5.122. View looking northeast across missile magazines, NIKE launch site. After vegetation removals the inner, outer, and kennel fences should be inspected, repaired where needed, and replaced where damaged or severely deteriorated (Olmsted Center, April 2008).
